UNDERWRITERS' LABS INC NORTHBROOK ILL
FIRE TESTS OF POLYURETHANE FOAM ROOF DECK CONSTRUCTION ON STEEL--ETC(U)
DEC 78 K RHODES

REPORT DOCUMENTATION PAGE		READ INSTRUCTIONS BEFORE COMPLETING FORM
1. REPORT NUMBER CR-79.004	2. GOVT ACCESSION NO.	3. RECIPIENT'S CATALOG NUMBER
4. TITLE (and Subtitle) FIRE TESTS OF POLYURETHANE FOAM ROOF DECK CONSTRUCTION ON STEEL DECKS		5. TYPE OF REPORT & PERIOD COVERED Final rept. December 1978

11. CONTROLLING OFFICE NAME AND ADDRESS Civil Engineering Laboratory Naval Construction Battalion Center Port Hueneme, CA 93043		12. REPORT DATE December 1978

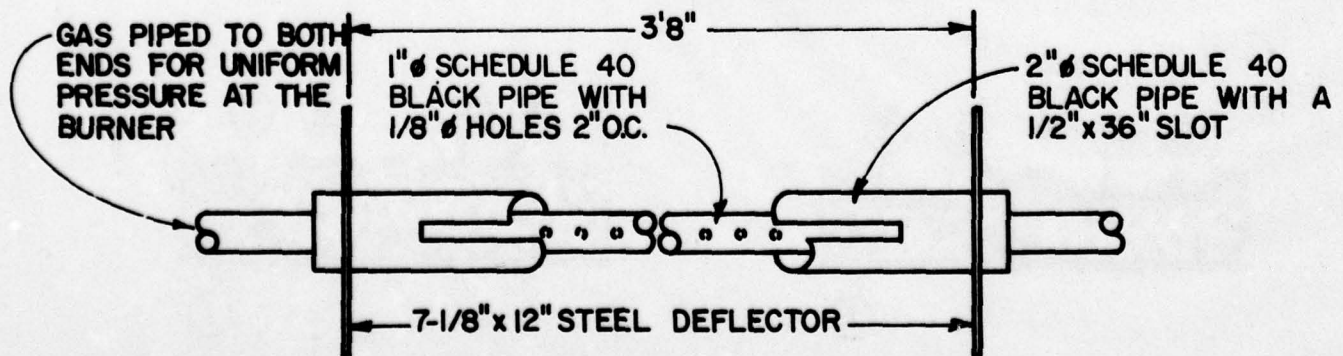
ILL. 1
USNC77

ROOFING TEST APPARATUS - SCHEMATIC

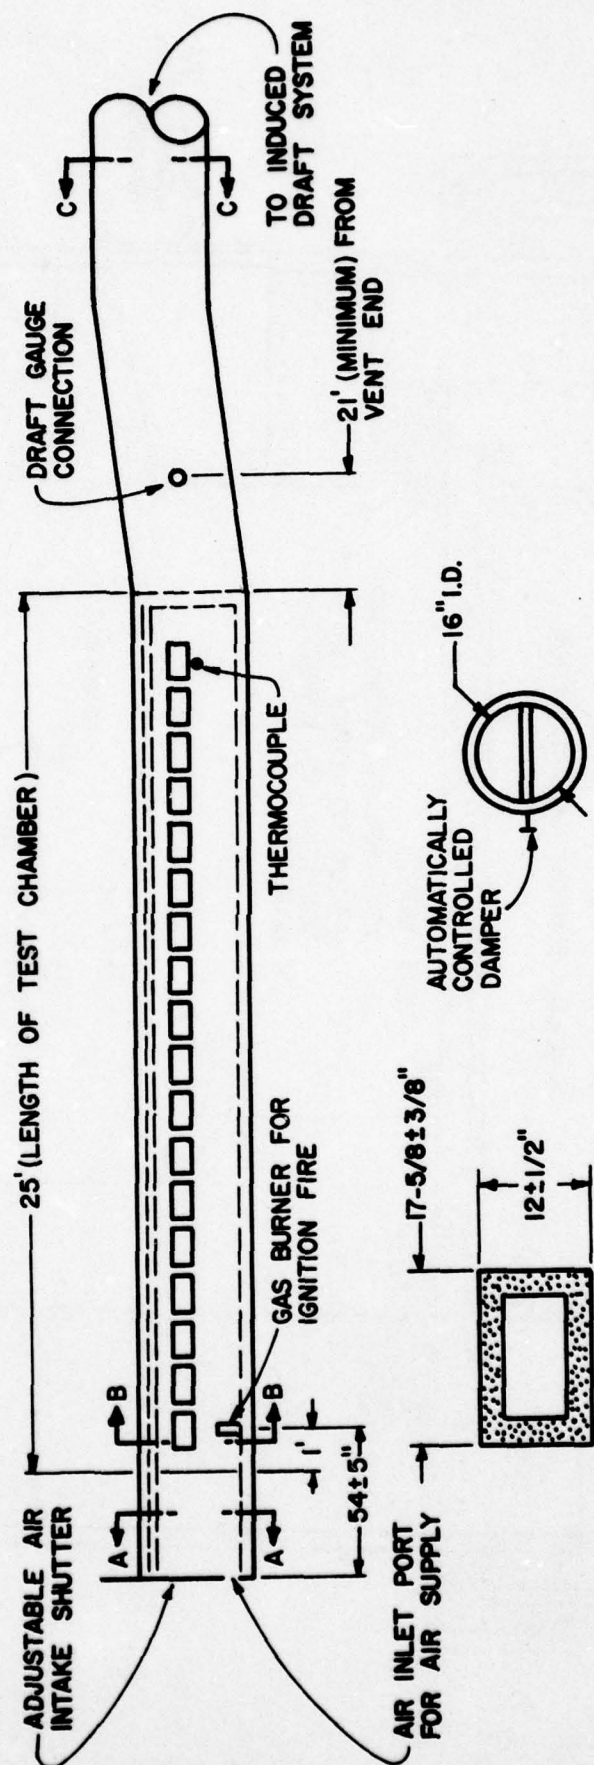
ILL. 3
USNC77

SECTION A-A
(RIB PANELS)

SECTION A-A
(9/16" CORRUGATED DECK)

DETAILS OF TEST FURNACE

SECTION C-C

SECTION A-A

SECTION B-B

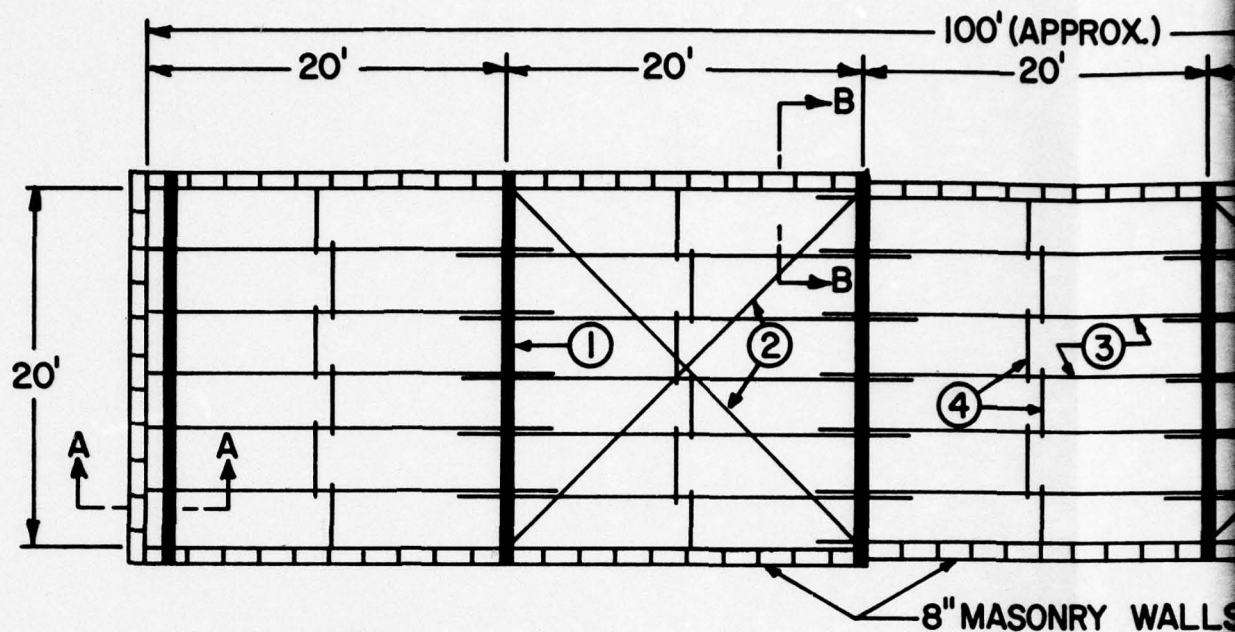
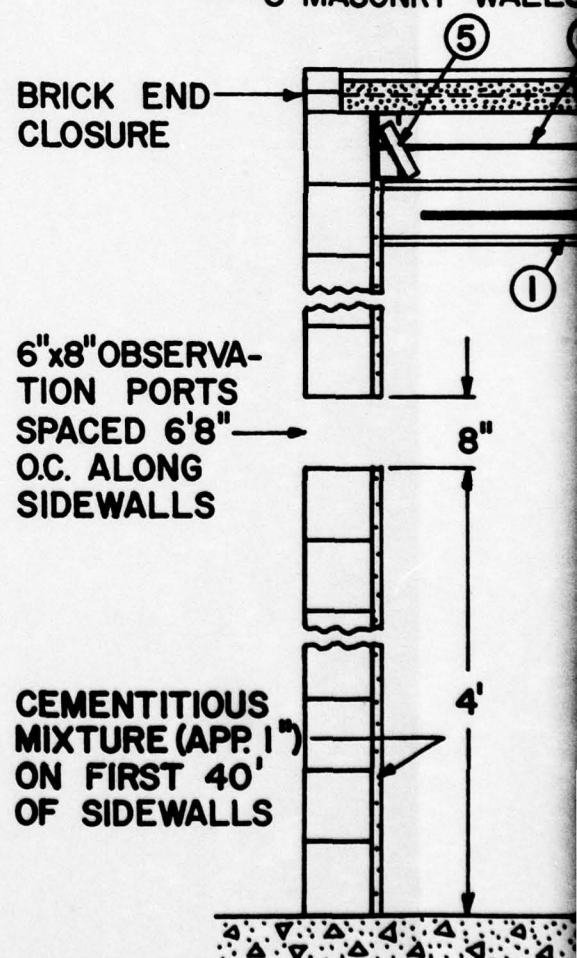
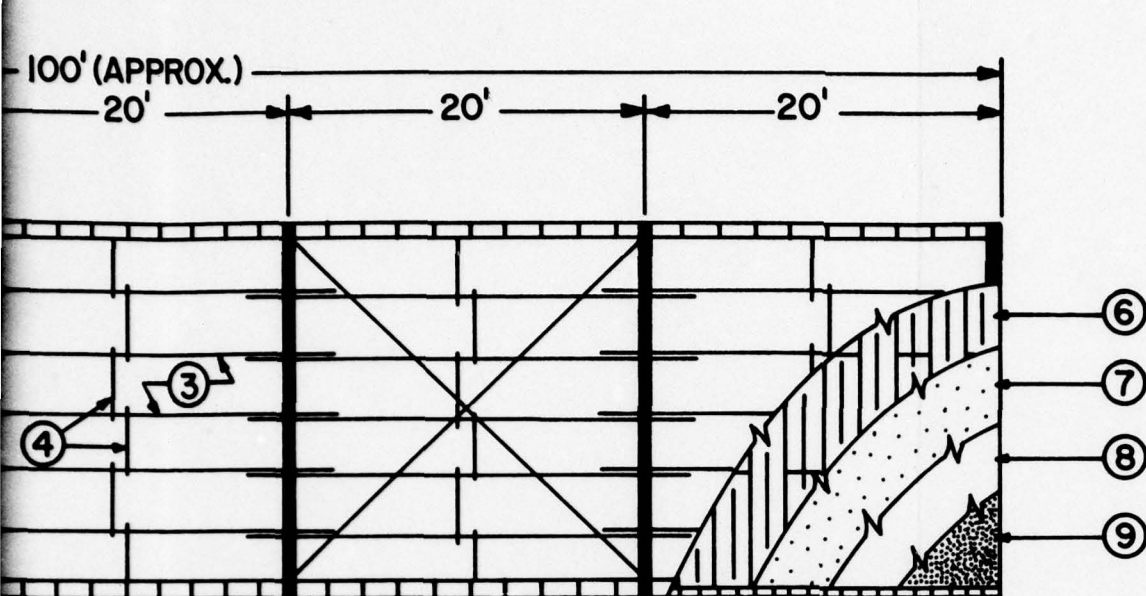
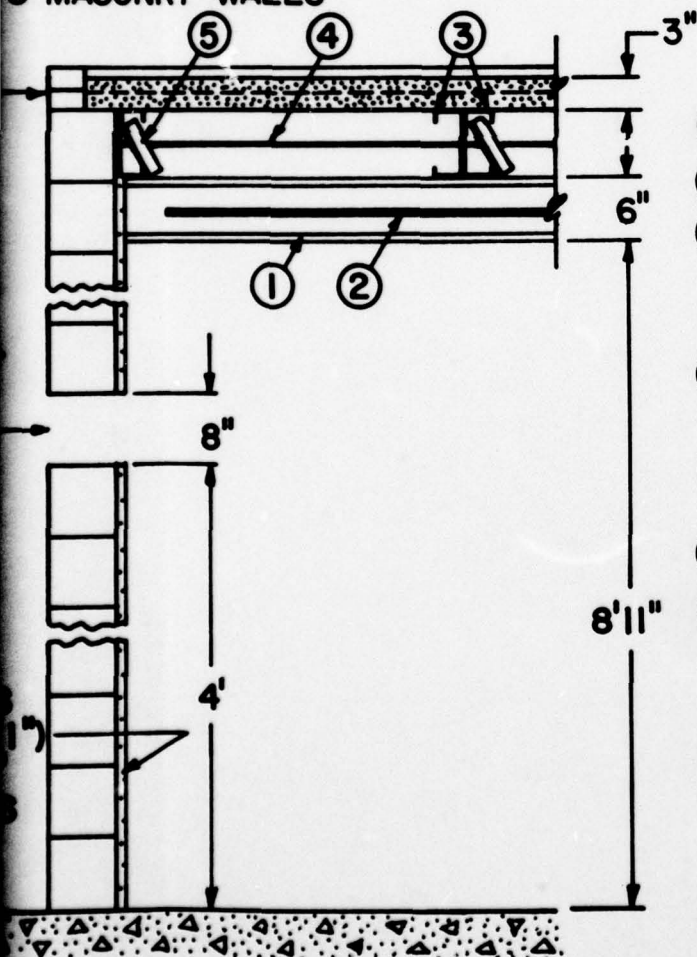
SECTION A-A

SECTION B-B

8" MASONRY WALLS

- ①—W6X16 STEEL BEAM
- ②—1/2"Ø STEEL ROD WITH TURNBUCKLES
- ③—7"DEEP, 14 GA. STEEL CHANNEL-SHAPED PURLINS, 24'11-1/4" LONG, SPACED 40" O.C.
- ④—3/8"Ø STEEL BRIDGING RODS
- ⑤—1-1/2"x1-1/2"x1/8"x6" LONG STEEL ANGLE, WELDED TO BEAM AND PURLIN (7/B EAM)
- ⑥—RIB METAL ROOF DECK PANELS, 26 GA. GALV. STEEL, 24" WIDE
- ⑦—SPRAY-APPLIED FOAM, 3" THICK
- ⑧—FLUID-APPLIED COATING, TWO COATS APPLIED AT A RATE OF 1.5 GAL /100 SQ FT FOR EACH COAT
- ⑨—NO. 11 ROOFING GRANULES APPLIED AT A RATE OF 50 LB/100 SQ FT

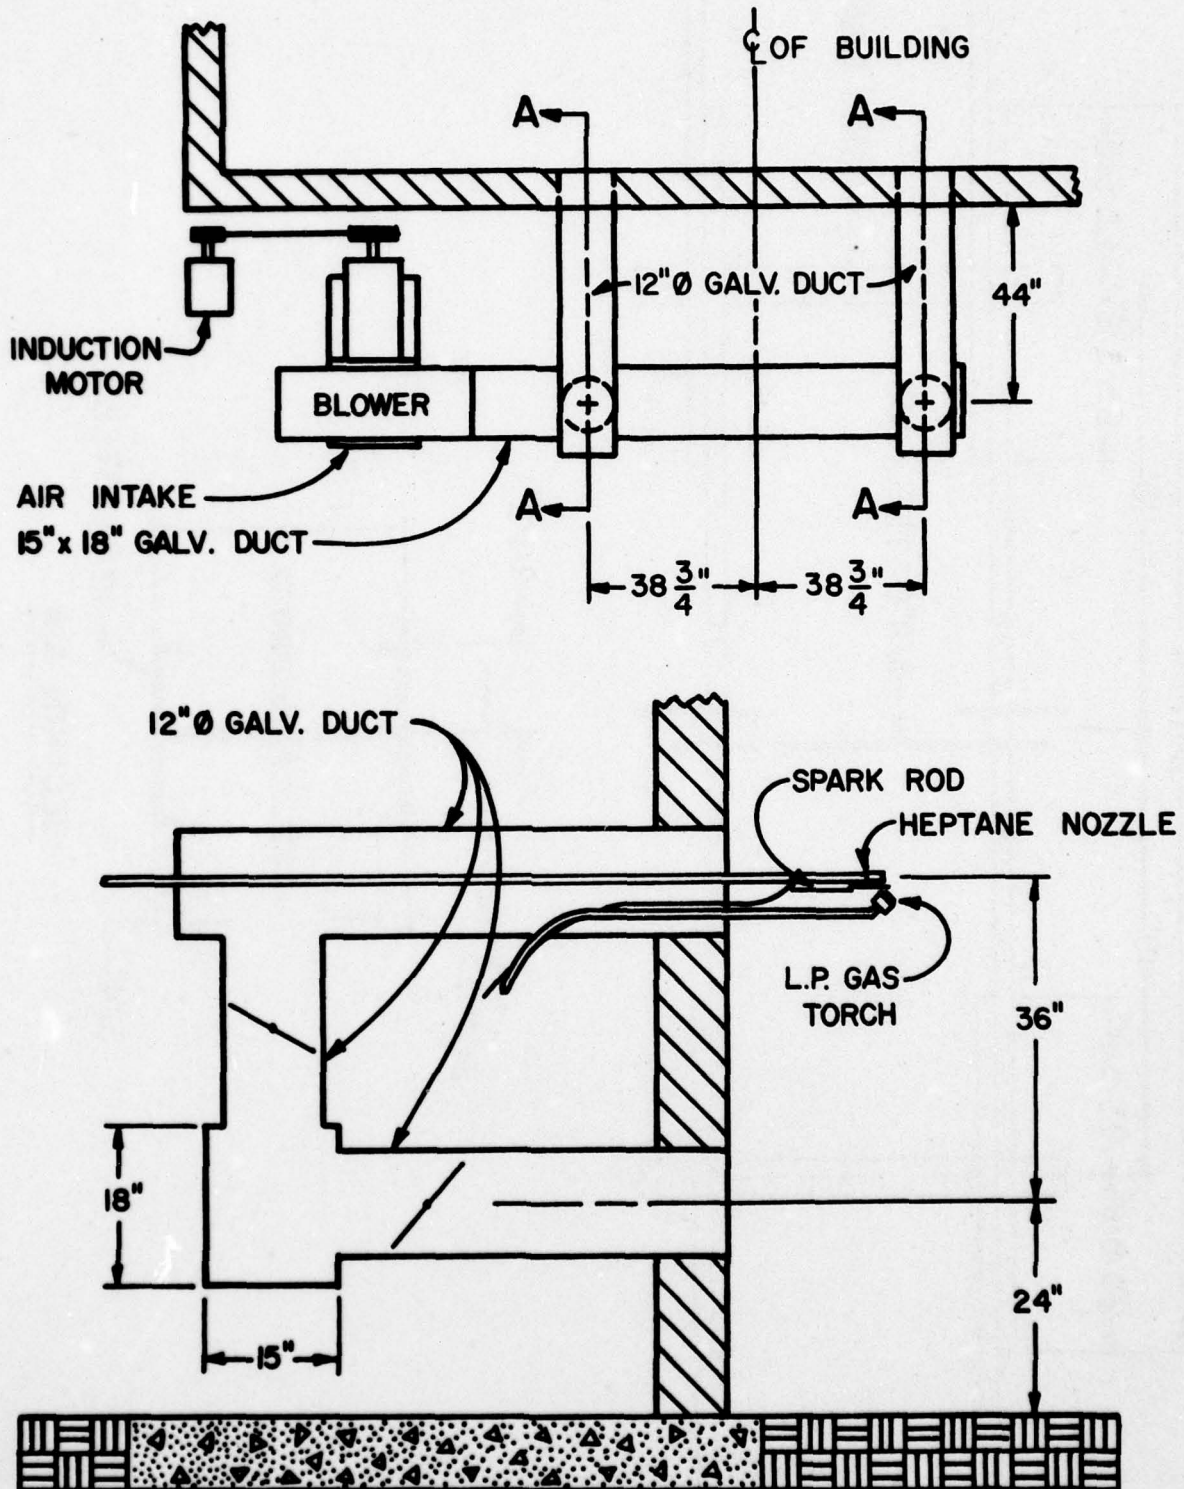
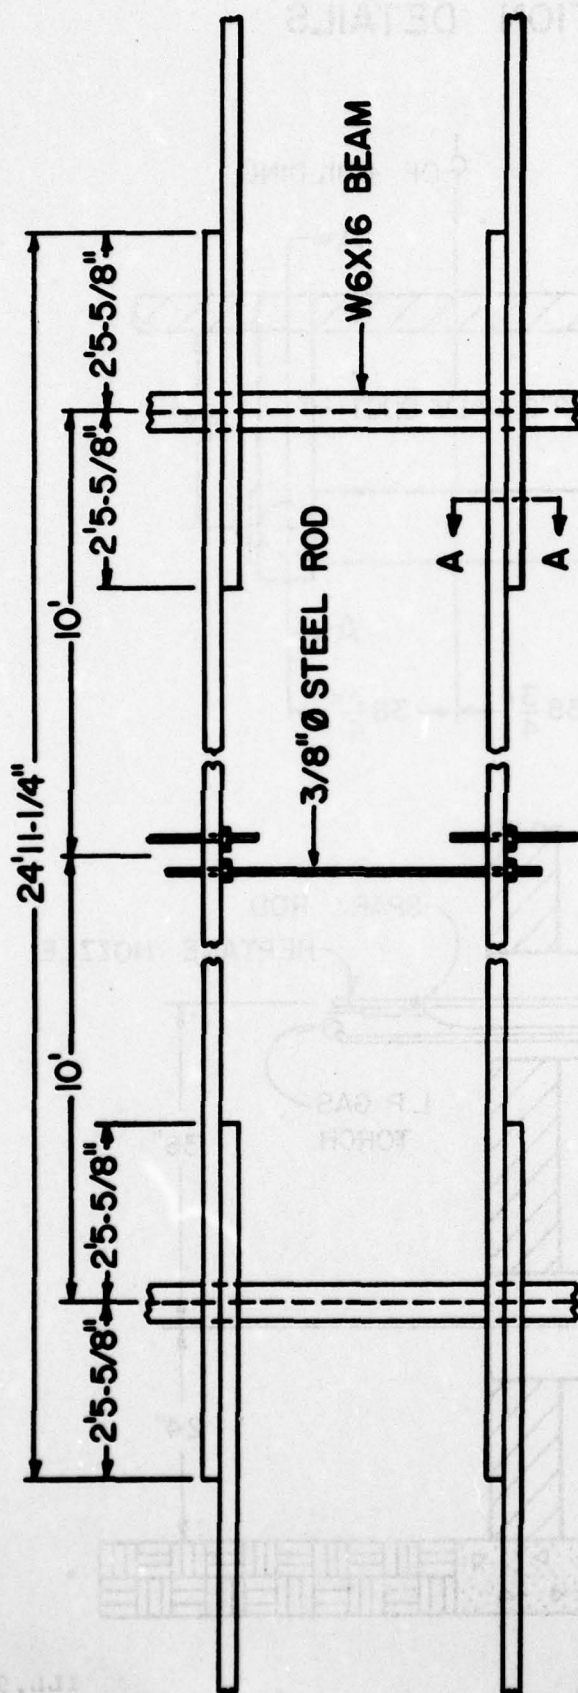
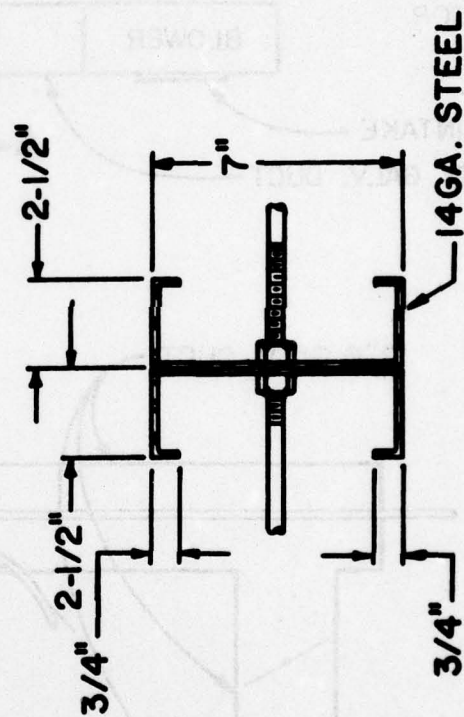
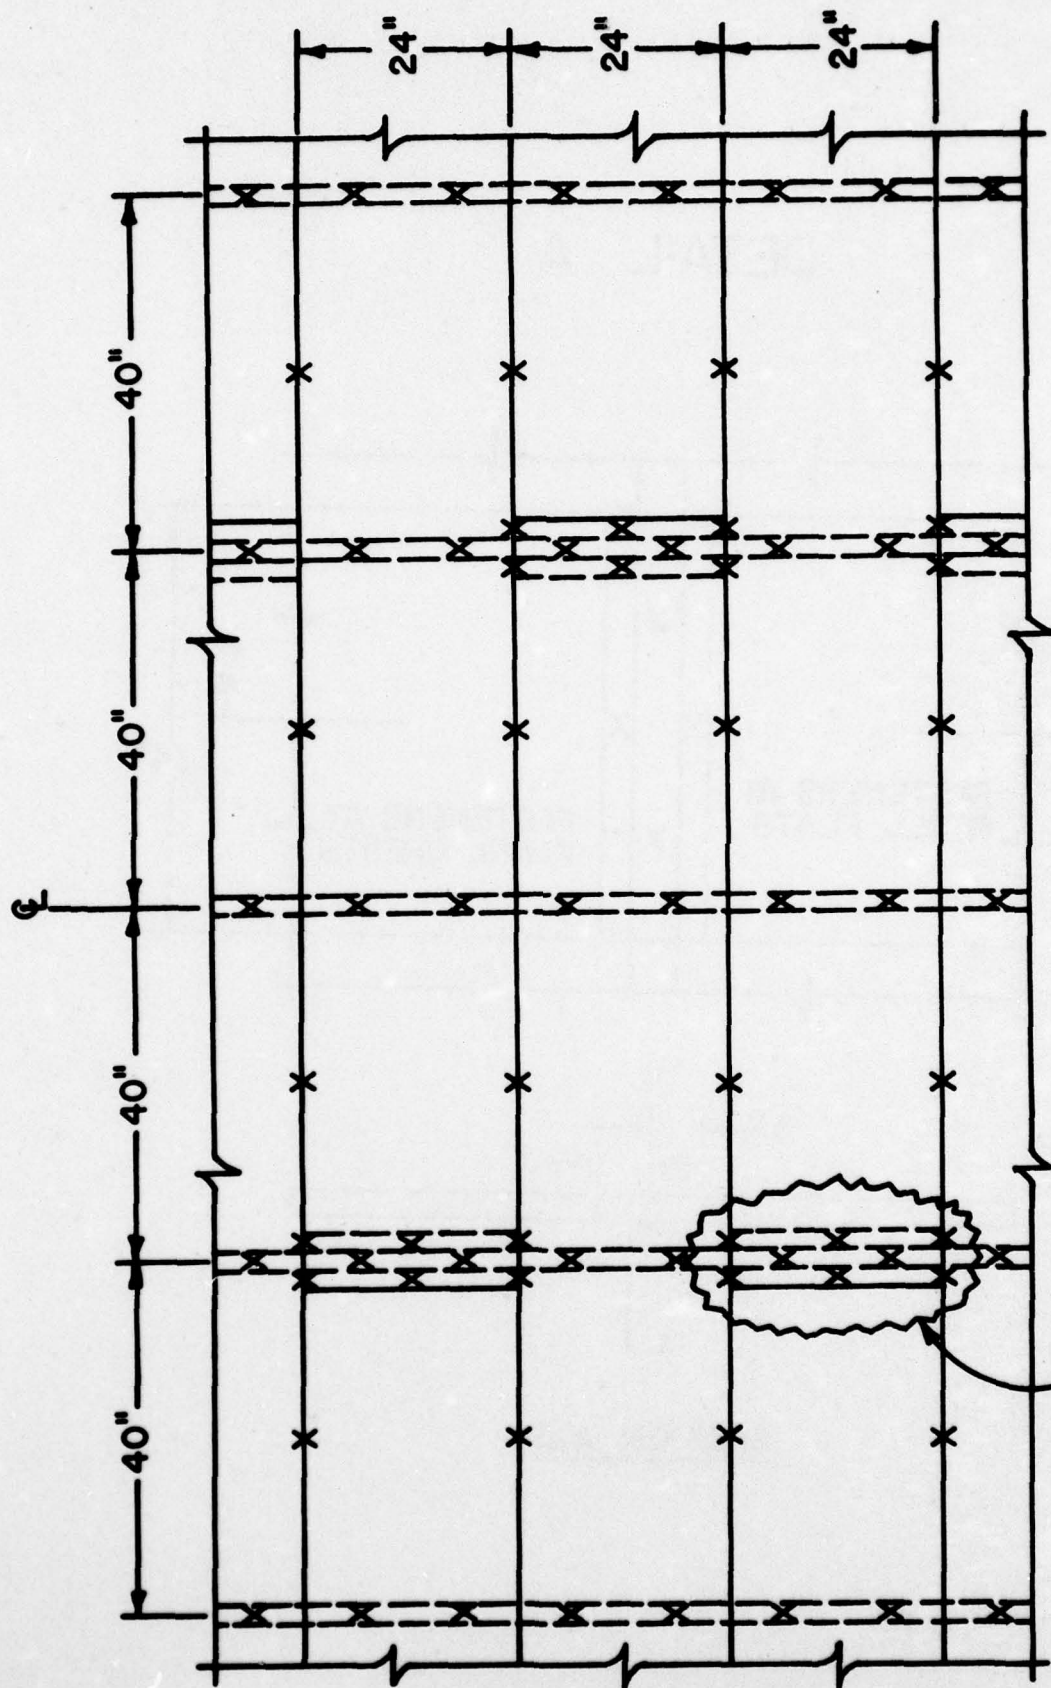
ILL.11
 USNC77

BLOWER AND IGNITION DETAILS

SECTION A-A

SEE DETAIL A
 X - NO. 1/4-14 x 1-1/4" TEKS/3 (ALL FASTENERS)

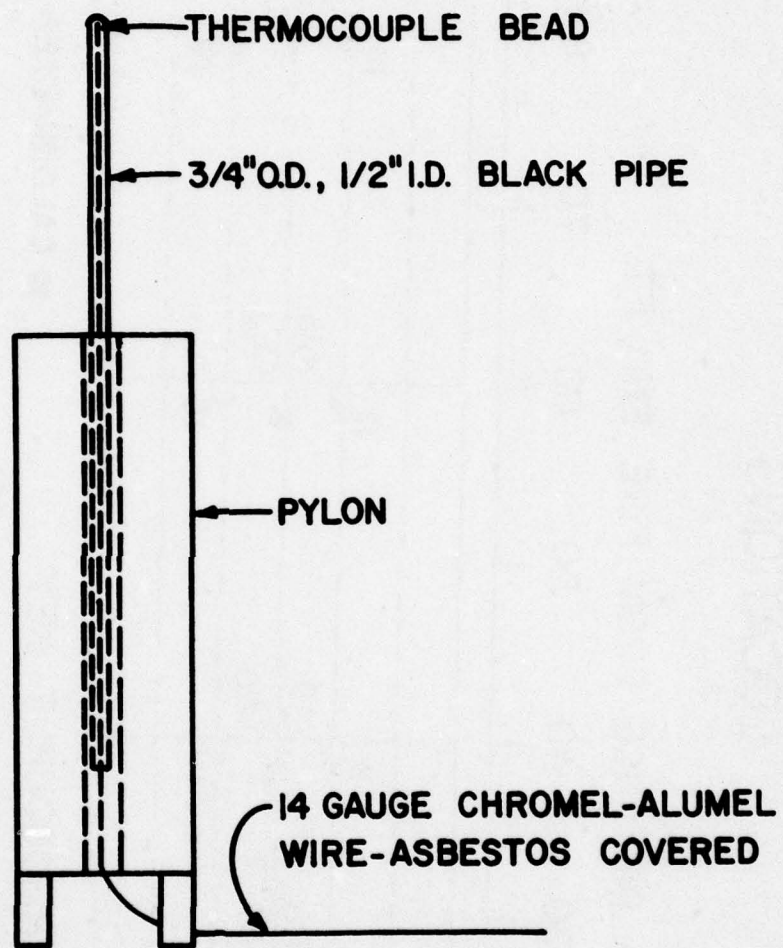
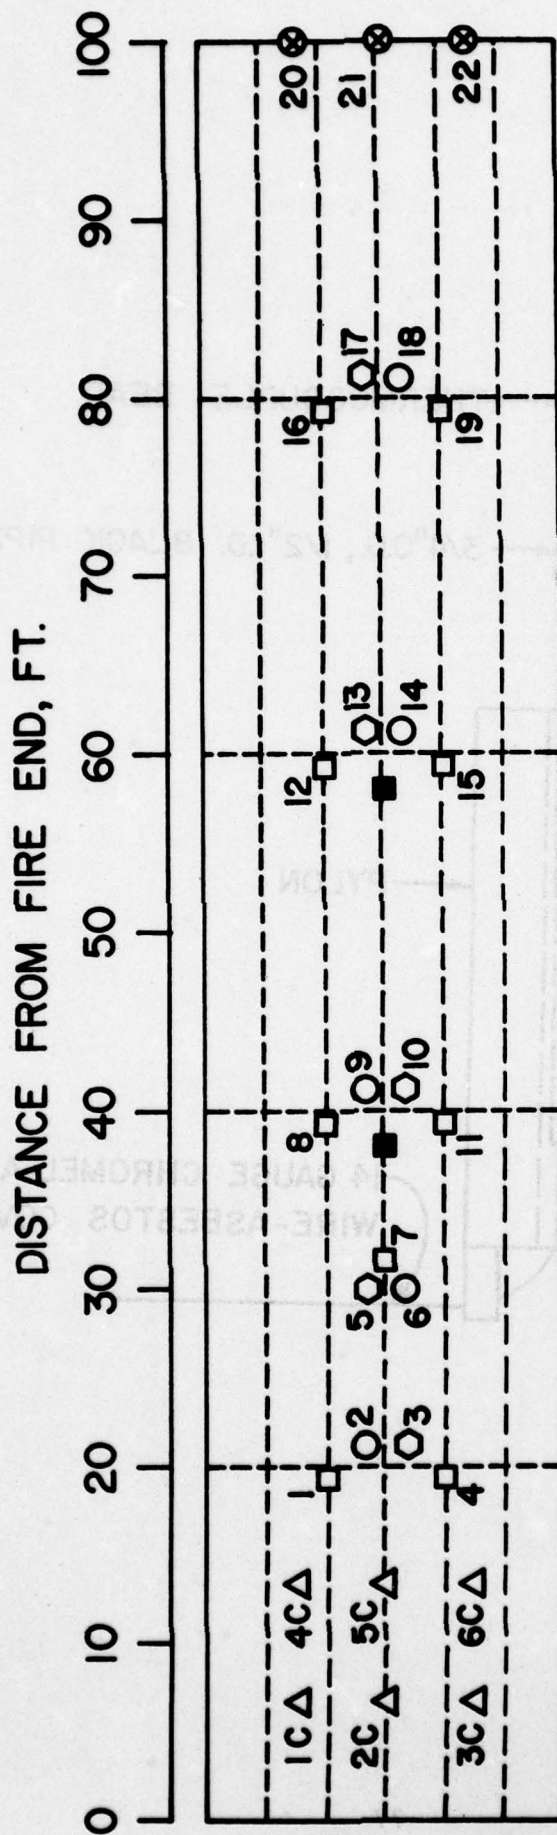
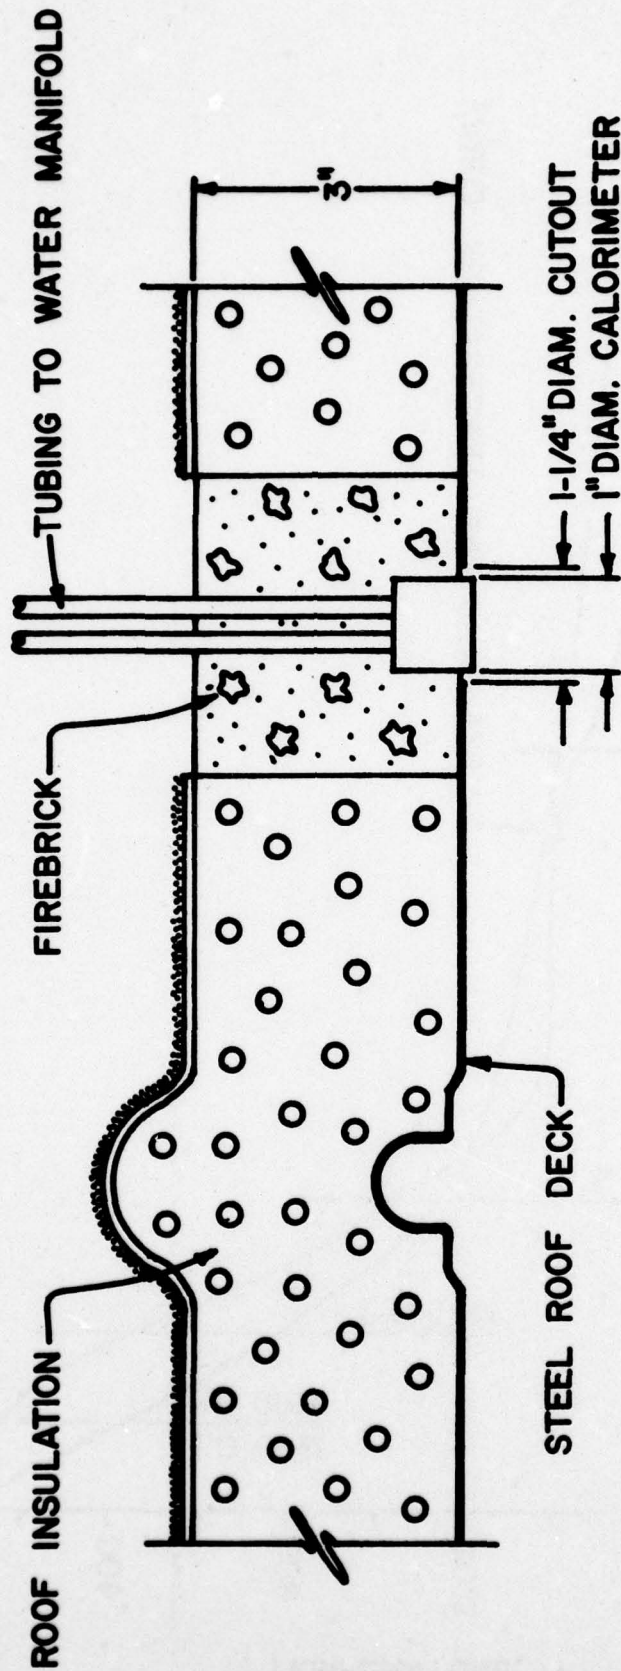
THERMOCOUPLE & CALORIMETER LOCATIONS

THERMOCOUPLE KEY

- Δ FIRE CONTROL (NOS. 1C-6C)
- IN AIR 2" BELOW PURLIN (NOS. 1,4,8,11,12,15,16,19)
- TOP OF STEEL ROOF DECK (NOS. 2,6,9,14,18)
- TOP OF ROOF DECK ASSEMBLY (NOS. 3,5,10,13,17)
- ⊗ IN AIR 3' BELOW STEEL ROOF DECK (NOS. 20,21,22)

■ CALORIMETER

CALORIMETER DETAIL
